ELEVATED TEMPERATURE, RESIDUAL COMPRESSIVE STRENGTH OF IMPACT-DAMAGED SANDWICH STRUCTURE MANUFACTURED OUT-OF-AUTOCLAVE[†]

**Brian W. Grimsley¹, James K. Sutter², Eric R. Burke¹,
Genevieve D. Dixon¹, Thomas G. Gyekenyesi², and Stanley S. Smeltzer¹**

ABSTRACT

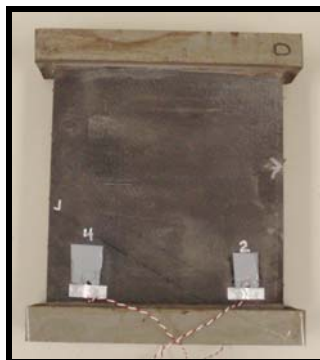
Figure 2. Front-view photograph of potted EWC and/or CAI test coupon.

The 20.32 cm x 15.24 cm curved EWC and CAI specimens were potted using Henkel® Hysol EA934NA epoxy potting compound following the supplier recommended bonding procedures. This resulted in a solid block of potting at each end of the specimen having dimensions of 17.8 cm x 5.4 cm x 1.6 cm. Photographs of the front-view and side-view of the potted coupon are displayed in Figure 2 and Figure 3, respectively. After the potting material cured at 25°C for 7 days, the ends of each potted specimen were machined to remove 3.175 mm from each end to ensure that the CFRP facesheets were flush with the surface of the potting material and that the potted ends were parallel to each other within ± 0.0254 mm. A photograph of the top-view of the potted specimen is shown in Figure 4.

Following the recommendation in ASTM C364 [26], all 100 EWC and CAI test coupons were instrumented using CEA-XX-187UW-350, 4.75 mm uniaxial strain gages supplied by Vishay Micro-Measurements[®], Raleigh, NC. As indicated in Figure 2, two gauges were used on each side of the coupons, each located in the lower corners, 2.54 cm above the potting and 2.54 cm from the vertical edge of the coupon. These 4 gauges on each coupon were monitored during compression testing to ensure parallel loading and inhibit bending. The 27 coupons intended for ambient testing were gauged at LaRC according to procedures specified by the gauge supplier.

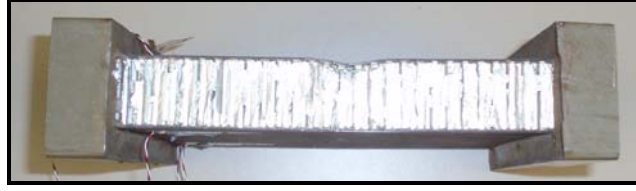
Figure 10. Photograph of ETW CAI from MTP-6010 showing typical facesheet buckling and core crushing valid failure mode.

With the exception of two invalid failures, all 38 of the BVID CAI failed by facesheet buckling inward across the width emanating from the impact region. The majority of these failures occurred in the impacted facesheet only, as indicated in Figure 10. In two MTP-6003 coupons and one from MTP-6010, failure was observed in both facesheets. In these three cases the damaged facesheet buckled inward and the undamaged facesheet delaminated with the outer plies buckling outward and the plies closet to the core buckling inward into the Al core. The two invalid failures experienced during the CAI testing were by delamination of the potting material at the ends. Both of these failures occurred in CAI coupons from MTP-6010 tested at 105°C. Up to 80 coupons were tested in the study at the various ETW conditions before a failure of this type occurred, however, once these two invalid failures occurred in succession, it was assumed that any future coupons would have been potted without adequate surface preparation and therefore would require clamping fixtures. Testing of MTP-6010 was suspended at this point while clamping fixtures were fabricated to accommodate clamping of the potted ends of the coupons. Therefore, the data set for MTP-6010 reported below was collected using no end-clamping fixture, in identical arrangement as that of the MTP-6003 data reported.
